Removal of the Fatou dam on the Baume River

The operation

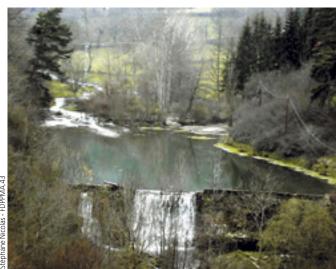
In 1907, a stone-masonry gravity dam was built on the Baume, creating a head drop of 6.1 metres. The dam was intended for hydroelectric generation at the Fatou power station. Hydroelectric production was terminated in the 1960s. The dam, located 400 metres from the confluence with the Loire, blocked river continuity. It was estimated that 6 000 cubic metres of sediment were blocked by the dam.

The Fatou dam and its reservoir in April 2004.

The Loire EPTB (public river-basin territorial agency) acquired the dam in 1985 in the framework of the land purchases for the *Serre de la Fare* programme. The poor condition of the dam raised a number of safety concerns and it was decided to remove it.

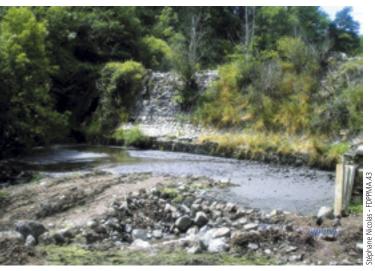
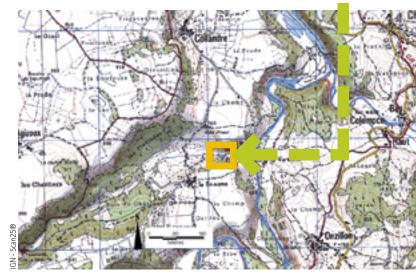
The Fatou dam.

The work consisted of totally removing the dam and the power station. It took place in four steps.

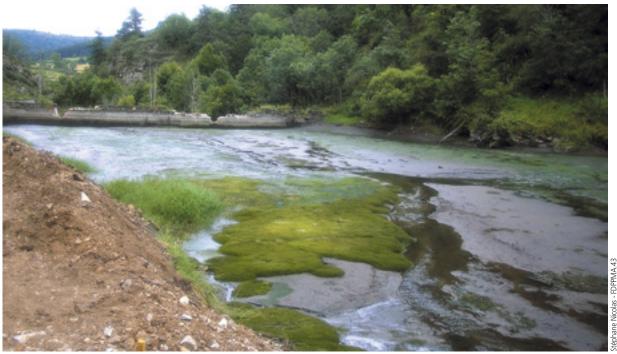
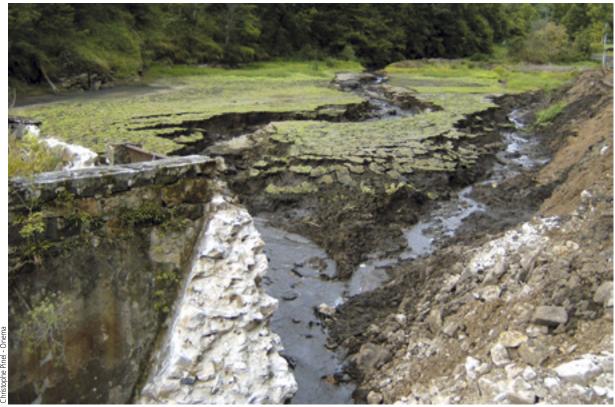
The Baume River in the process of re-establishing its bed in the mud of the former reservoir in July 2007.

• During the low-flow period in July 2007, the reservoir was drained. The river was first diverted to one side along the reservoir to a point downstream of the dam. It was then possible to drain the reservoir progressively. A settling basin was created downstream of the dam to limit the quantities of mud entering

- The site was dredged once the sediment in the reservoir had dried sufficiently. Following a check to ensure its non-toxicity, the sediment was stored to dry for one year upstream of the reservoir.
- The gates and fixed elements of the dam were then dismantled. The power station was razed.
- The banks were then restored to their original condition. They were consolidated in certain places using materials drawn from the dam. Gravel was deposited in the riverbed.

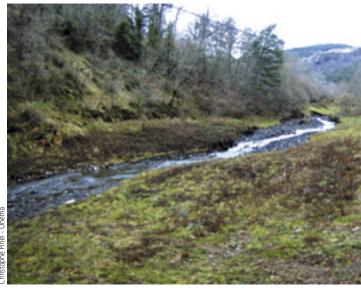
At the site of the former dam, the natural hydraulic gradient was restored. Along the river, the vegetation rapidly resumed its natural development without any planting being required. Within the former reservoir, rapid flows in the form of running facies reappeared. A coarser substrate also appeared. In 2008, just one

The Baume River in the former Fatou reservoir in December 2008.

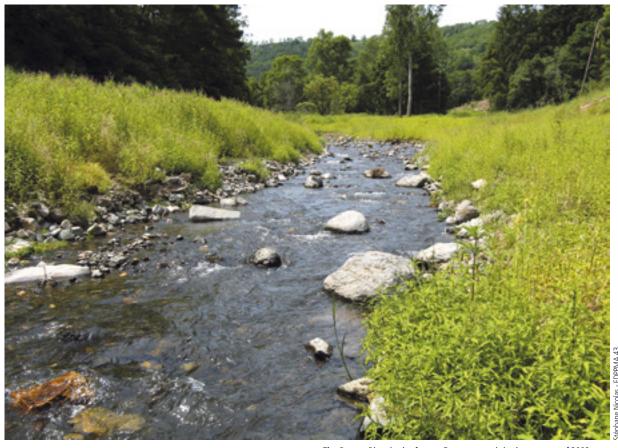
The Baume River in the former Fatou reservoir in the summer of 2008.
