# Removal of the Ver mill weir on the Sienne River

## The operation

The Sienne is a coastal river, 80 kilometres long, that flows into the English Channel in the harbour of the town of Regnéville. Its basin covers a surface area of 580 square kilometres. The area is essentially agricultural, dominated by grazing and fodder crops (maize) with some grain crops. The soil is fairly impermeable (orthogneiss and granite) with relatively steep slopes in a rather hilly area. Farm fields represent a sizeable percentage of the land cover, however the intensity of the pressures exerted on aquatic environments is limited. The chemical quality of water is rather high and the main disturbances are hydromorphological due to the presence of transversal structures. The Sienne is fragmented and fish have a difficult time accessing the upper reaches and the tributaries.

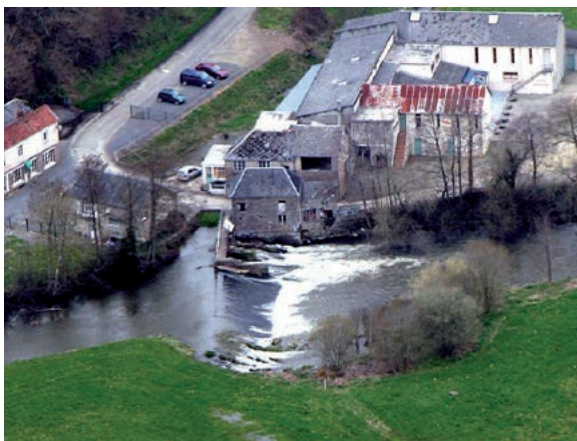
Aerial view of the Ver mill site before the removal of the weir. April 2006

The Ver mill, built centuries ago, had not served an economic purpose for decades. The mill weir, 1.7 metres high, was in very poor condition. A night club exists on the left bank.

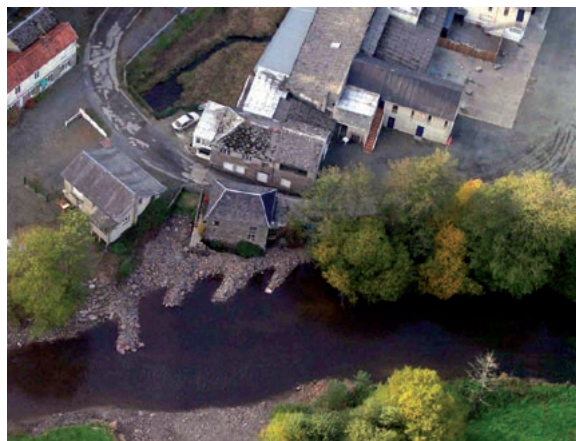
Aerial view of the site after the removal of the weir. Automne 2011.

The removal of the Ver mill weir made possible a return to a natural riverbed in the formerly impounded reach, over a distance of 1.7 kilometres.

The Ver mill weir was completely removed. The rubble of the stone weir was used on the right bank to create groynes to centre flood waters. The project included maintenance of the riparian vegetation upstream. A nearby pond was restored to replace the mill pond that had been used by the local fire department. Finally, fences and watering points were set up on neighbouring lands.

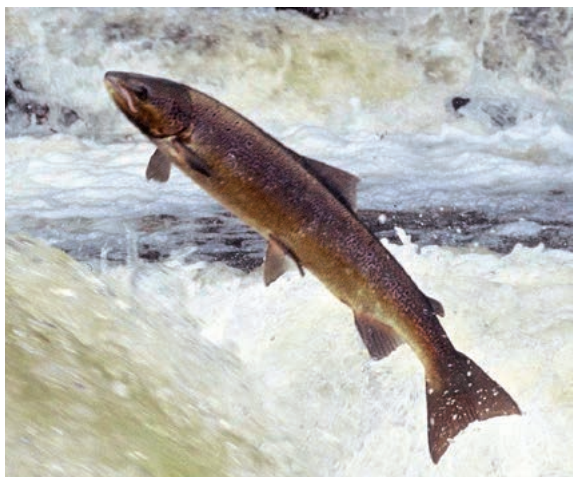
An Atlantic salmon attempting to overcome the Ver mill weir. Autumn 2009.

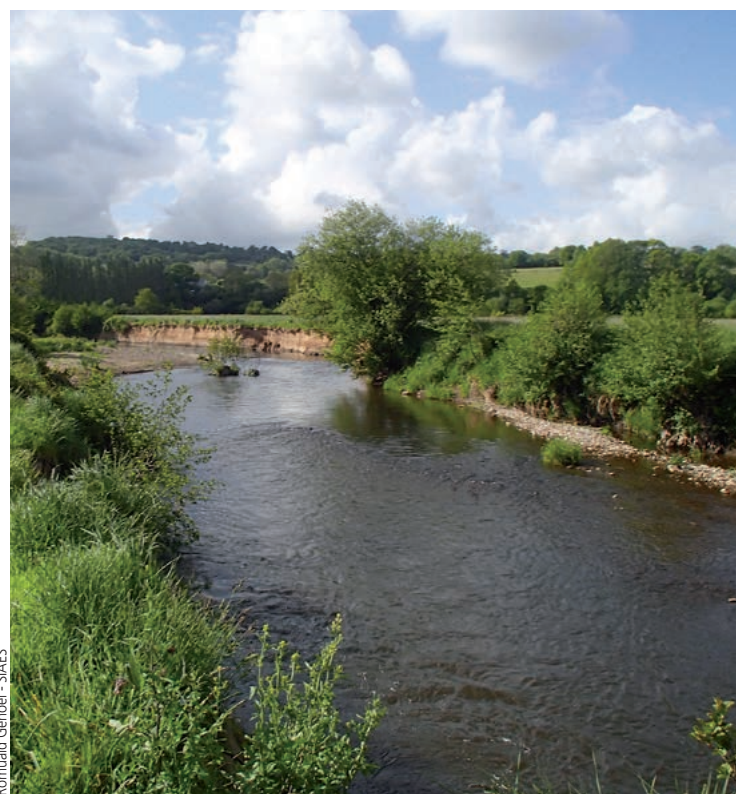
Reactivation of sediment transport in the former impoundment following removal of the weir. May 2013.

Geomorphologically speaking, the Sienne would appear to have returned to a more natural hydraulic gradient. Post works, major quantities of coarse sediment reappeared on the site of the former impoundment. This sediment has been and continues to be transported by two-year winter floods. The river has

also recommenced natural adjustment via lateral erosion in the concavity sections of meanders.
